Service Bulletin	Revision B
Warranty: Depends on Install Date	No SPM Detected or Error 02A0 on Climb Mill	Revised Date: 10/23/13
Time Required: 60 Minutes	Models Affected: All CS17 or CS22 Climb Mills (excludes CS23)	Prepared by: Kevin Oeltjenbruns

DESCRIPTION

No SPM Detected or Error 02A0 is present on the console or the unit goes into Pause Mode without prompting.

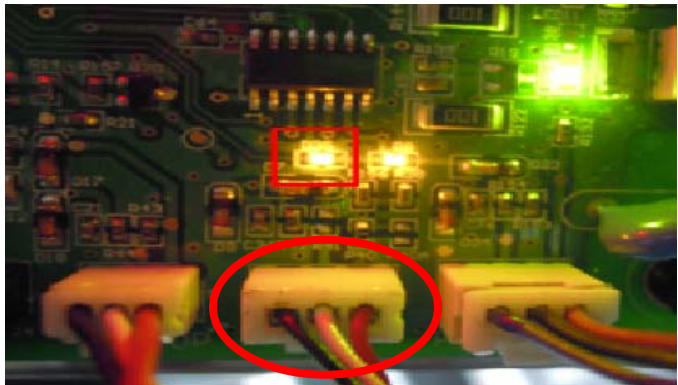
FIGURE A

1. The most obvious issue that could cause this type of error is if the speed sensor is not communicating with the LCB.
 - a. Check the connection of the speed sensor cable to the LCB (Figure A).
 - b. Check to see if LED D35 on the LCB (Figure A) is lit when the brake is in the release position (to the left). If it is not lit, rotate the stairs ½ a revolution to see if LED D35 flashes during movement.
 - c. If LED D35 is not lit, and does not light when the stairs are moved, replace the speed sensor.
 - d. If LED D35 is lit, clean the speed sensor of any debris and make sure it is spaced evenly on the optic disc (Figure B), then retest.

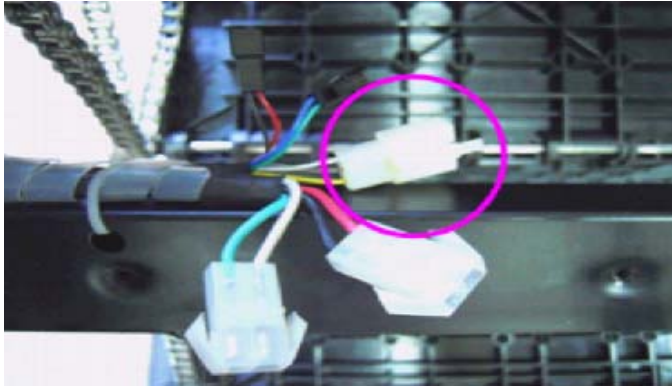
FIGURE C

3. If neither software nor the speed sensor is causing the issue, the next thing to check is the brake.
 - a. Remove the Matrix logo cover from each side of the unit.
 - b. Check the connection of the brake wire at the extension (Figure C) and LCB (Figure D).

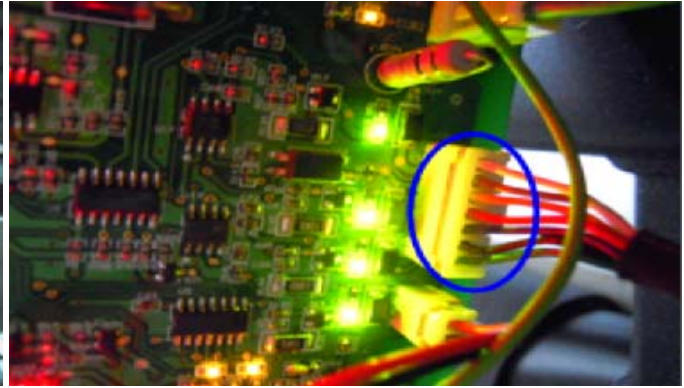
FIGURE D

- c. Unplug the brake wire from the extension wire which runs to the LCB.
 - d. Test the brake by taking a resistance reading on pins 1 & 2 of the brake wire. The resistance reading should be approximately 52 Ω .
 - If the resistance reading is less than 52 Ω (or if there is no resistance reading), replace the brake.
 - If the resistance reading is correct, replace the brake extension cable.
4. If software, the speed sensor, and the brake are all eliminated from consideration, the issue is likely with the hardware used to mount the drive set to the frame. It is possible that the correct hardware was not used or was not correctly assembled at the factory.
 - a. Remove the Matrix logo cover from each side of the unit to access the drive set.
 - b. Remove the fan / brake plate from the drive set by removing 4 screws (Figure E) and disconnecting the brake and fan wires (Figure F).
