<b>Service Bulletin</b>	<b>Revision</b> B
<b>Warranty:</b> Depends on Install Date	<b>Troubleshooting 02A0 Errors on Matrix Treadmills</b>	<b>Revised Date:</b> 12/21/10
<b>Time Required:</b> Varies	<b>Models Affected:</b> T5x, T7x, & T7xe Treadmills	<b>Prepared by:</b> Kevin Oeltjenbruns

Some Matrix customers have seen error code 02A0 on Matrix treadmills for a variety of reasons.

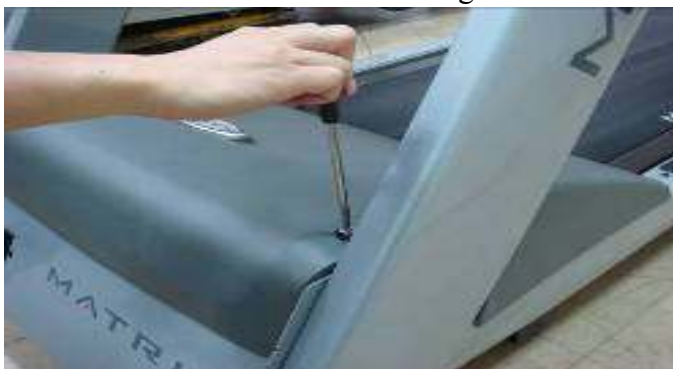
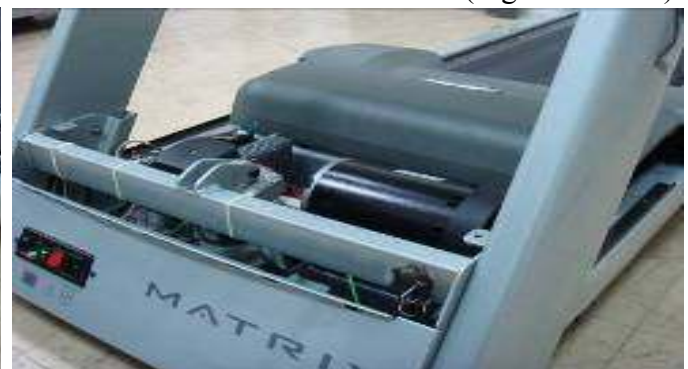
Figure A

1. Turn off power to the treadmill and remove the power cord from the wall outlet and machine.
2. Remove the 2 screws holding the motor cover to the frame and remove the cover (Figures A & B).

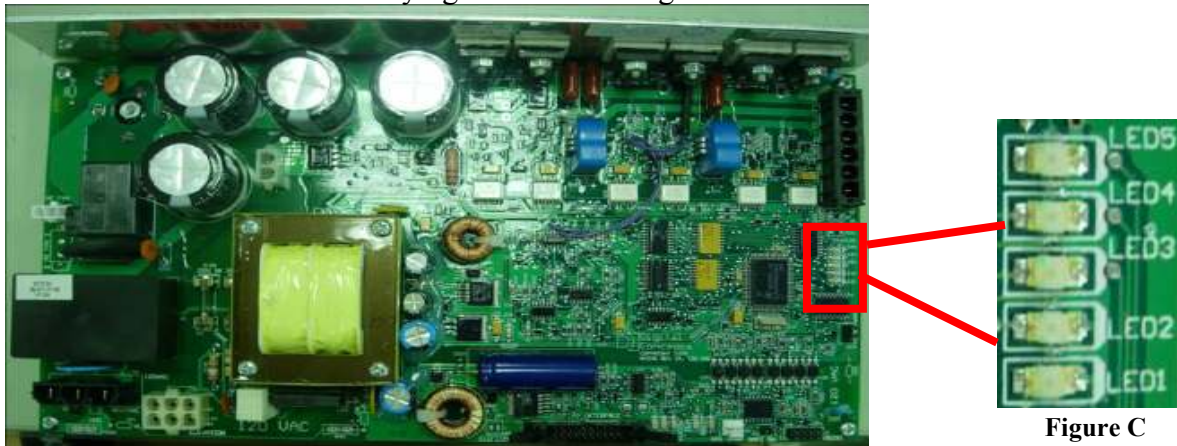
**Figure C**

1) Check the flash rate of the diagnostic LED's on the MCB (LED1, LED2, and LED3 – Figure C) by counting the number of times the 3 LED's flash simultaneously between pauses.

2) Review the MCB Error Table below for a description of how the MCB interprets the error condition (these blink codes should directly correspond with a new console error code if the 3.0 BETA software version is loaded on the console). The MCB flash code and / or the BETA software version error code should be utilized for identifying areas to investigate to confirm what the root cause of the 02A0 error is.

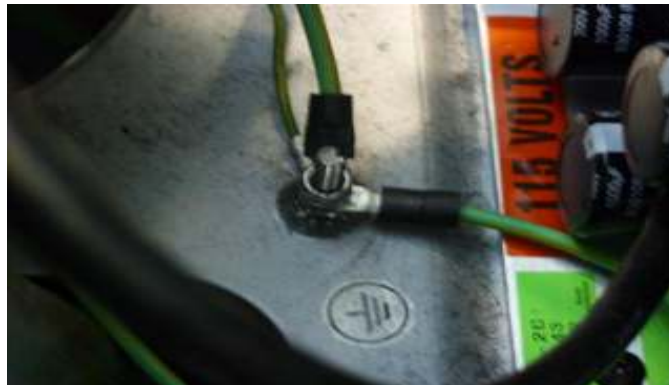
**Figure G**

- 4) The next area to investigate is the electrical resistance from the motor housing to the treadmill frame ground point that is used to bleed off potential motor charge build up (Figure G). The resistance should be measured with power to the treadmill in the OFF position and should measure approximately 20M ohms (18M – 22M ohms).

- If the resistance is higher than this, investigate the green wire connections from the motor housing to the treadmill frame grounding stud (a 20M ohms resistor should be enclosed in black heat shrink connected in series on the green wire).

- If the check above identifies a problem, correct the problem and retest the treadmill.
